Manhole Inspection Summary

Manhole # S43I2_012MH

Location Address: **1233 Church St.**

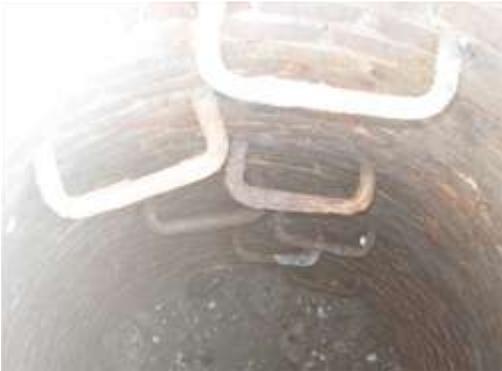
Steps Count: **7** Missing: **0** **Corroded**

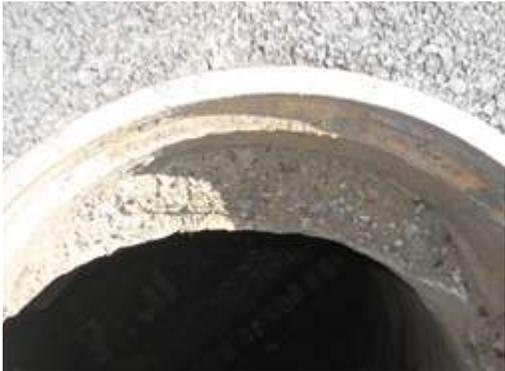
Defect 2

Frame Offset: **4** (in.)

Frame offset.

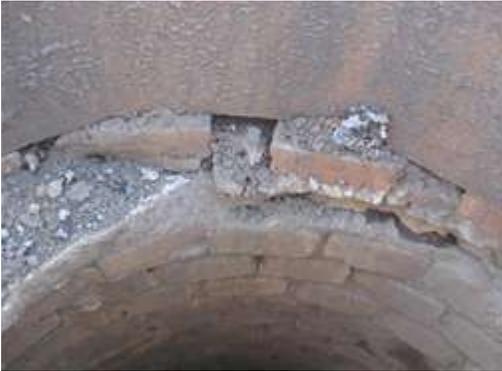
Defect 1

Condition: Sound Cracked Root Intrusion Loose Brick **Deteriorated**

Infiltration: None **Joint** **Cracks** Mortar Roots Wall

Deteriorated Chimney structure.

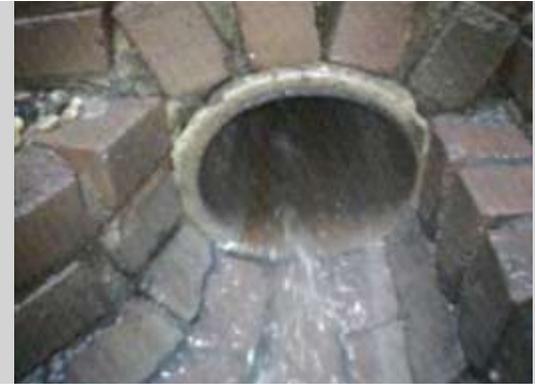
12 O'Clock Outflow

8 in. Circular Gravity Sewer
Pipe Out @ 12 O'Clock

Pipe Height: **8.4** (in.) Rod and Bar (Angled)
Pipe Material: **Clay** Pipe Lined
Invert Depth: **12.90** (ft.) Flow Characteristics: **Fast**
Deposits: None Mud Sludge **Debris** Grease
Silt Depth: (in.) Deposits Extent:
Infiltration: **None** Pipe Seal Cond: **Sound**

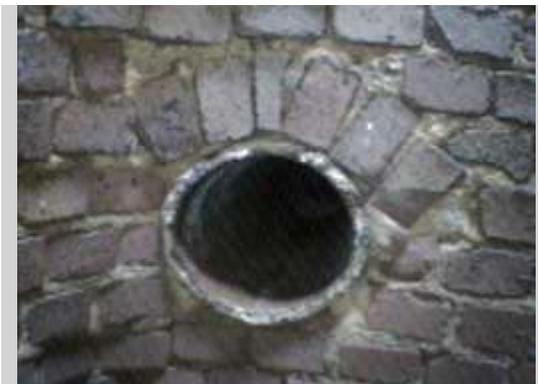
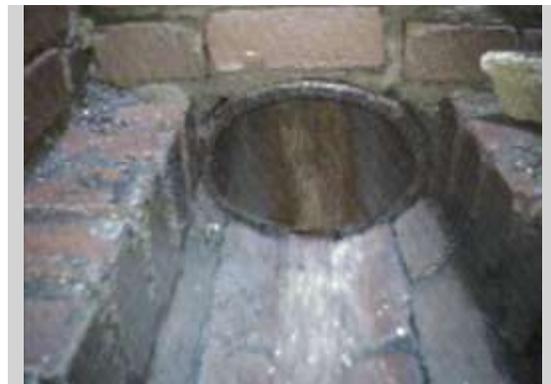
6 O'Clock Inflow

8 in. Circular Gravity Sewer
Pipe In @ 6 O'Clock

Pipe Height: **8.4** (in.) Rod and Bar (Angled)
Pipe Material: **Clay** Pipe Lined
Invert Depth: **9.48** (ft.) Flow Characteristics: **Fast**
Deposits: None Mud Sludge **Debris** Grease
Silt Depth: (in.) Deposits Extent:
Infiltration: **None** Pipe Seal Cond: **Sound**

Drop: **Outside** **Rod and Bar**
Angled: **Yes** Reading: **11.86** (ft.)
Inv Depth: **12.86** (ft.)
Drop Condition: **Open**

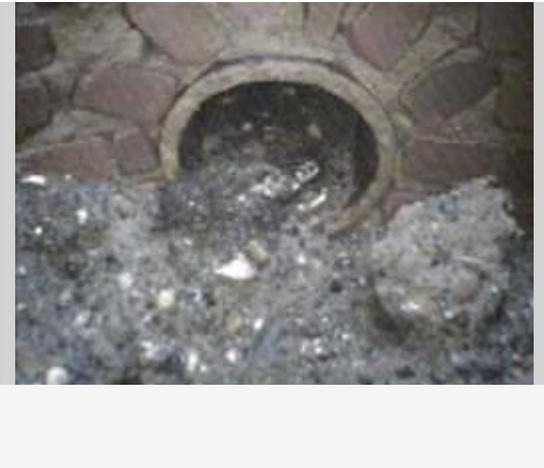
8 O'Clock Inflow

Unable to accurately measure influent pipe @ 8 O'Clock

8 in. Circular Service Sewer
Pipe In @ 8 O'Clock

Pipe Height: **3.6** (in.) Rod and Bar (Angled)
Pipe Material: **Clay** Pipe Lined
Invert Depth: **1.00** (ft.) Flow Characteristics: **None**
Deposits: None Mud Sludge **Debris** Grease
Silt Depth: **6** (in.) Deposits Extent: **Heavy**
Infiltration: **None** Pipe Seal Cond: **Cracked**
